Dove Creek

Dove Creek Facility Statistics

Facility Description

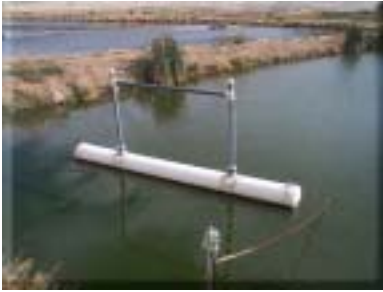
Water level control

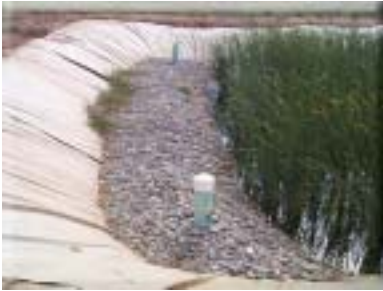
Buried Inlet pipe with stub-outs for maintenance

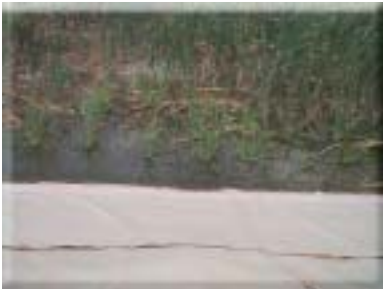
Cattails establishing themselves

Each of the five cells are about 75 percent vegetation, 15 percent bare soil, and 10 percent open water. The only plant species present is cattail (*Typha latifolia*)

Cells were originally planted in fall 1999 with 9000 cattails from Minnesota at a cost of \$0.33 per plant. In summer 2000, 2700 cattails were replanted. Topsoil from the site was used for the plantings.

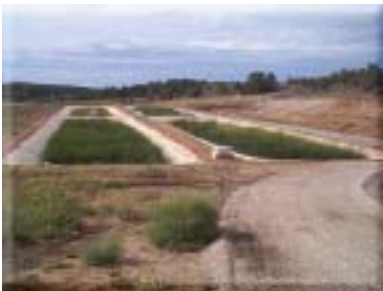
View of parallel wetland cells

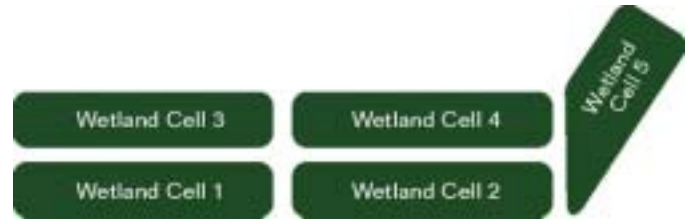
The wetland system consists of 4 surface-flow cells and 1 sub-surface flow cell covering approximately 1 acre of ground.

As shown in the schematic, the wetland cells are generally rectangular, with some curves added in order to fit the site location.

Design features include: 45-mil polypropylene liners on all cells; distribution boxes to allow bypass of any one cell for maintenance; infinitely-adjustable flow control devices for each wetland cell; recirculation pump and lines that will allow recirculation to the wetlands headworks and/or to the treatment plant headworks.
